# Gardner Division EMP

June 25, 2001 Site Visit

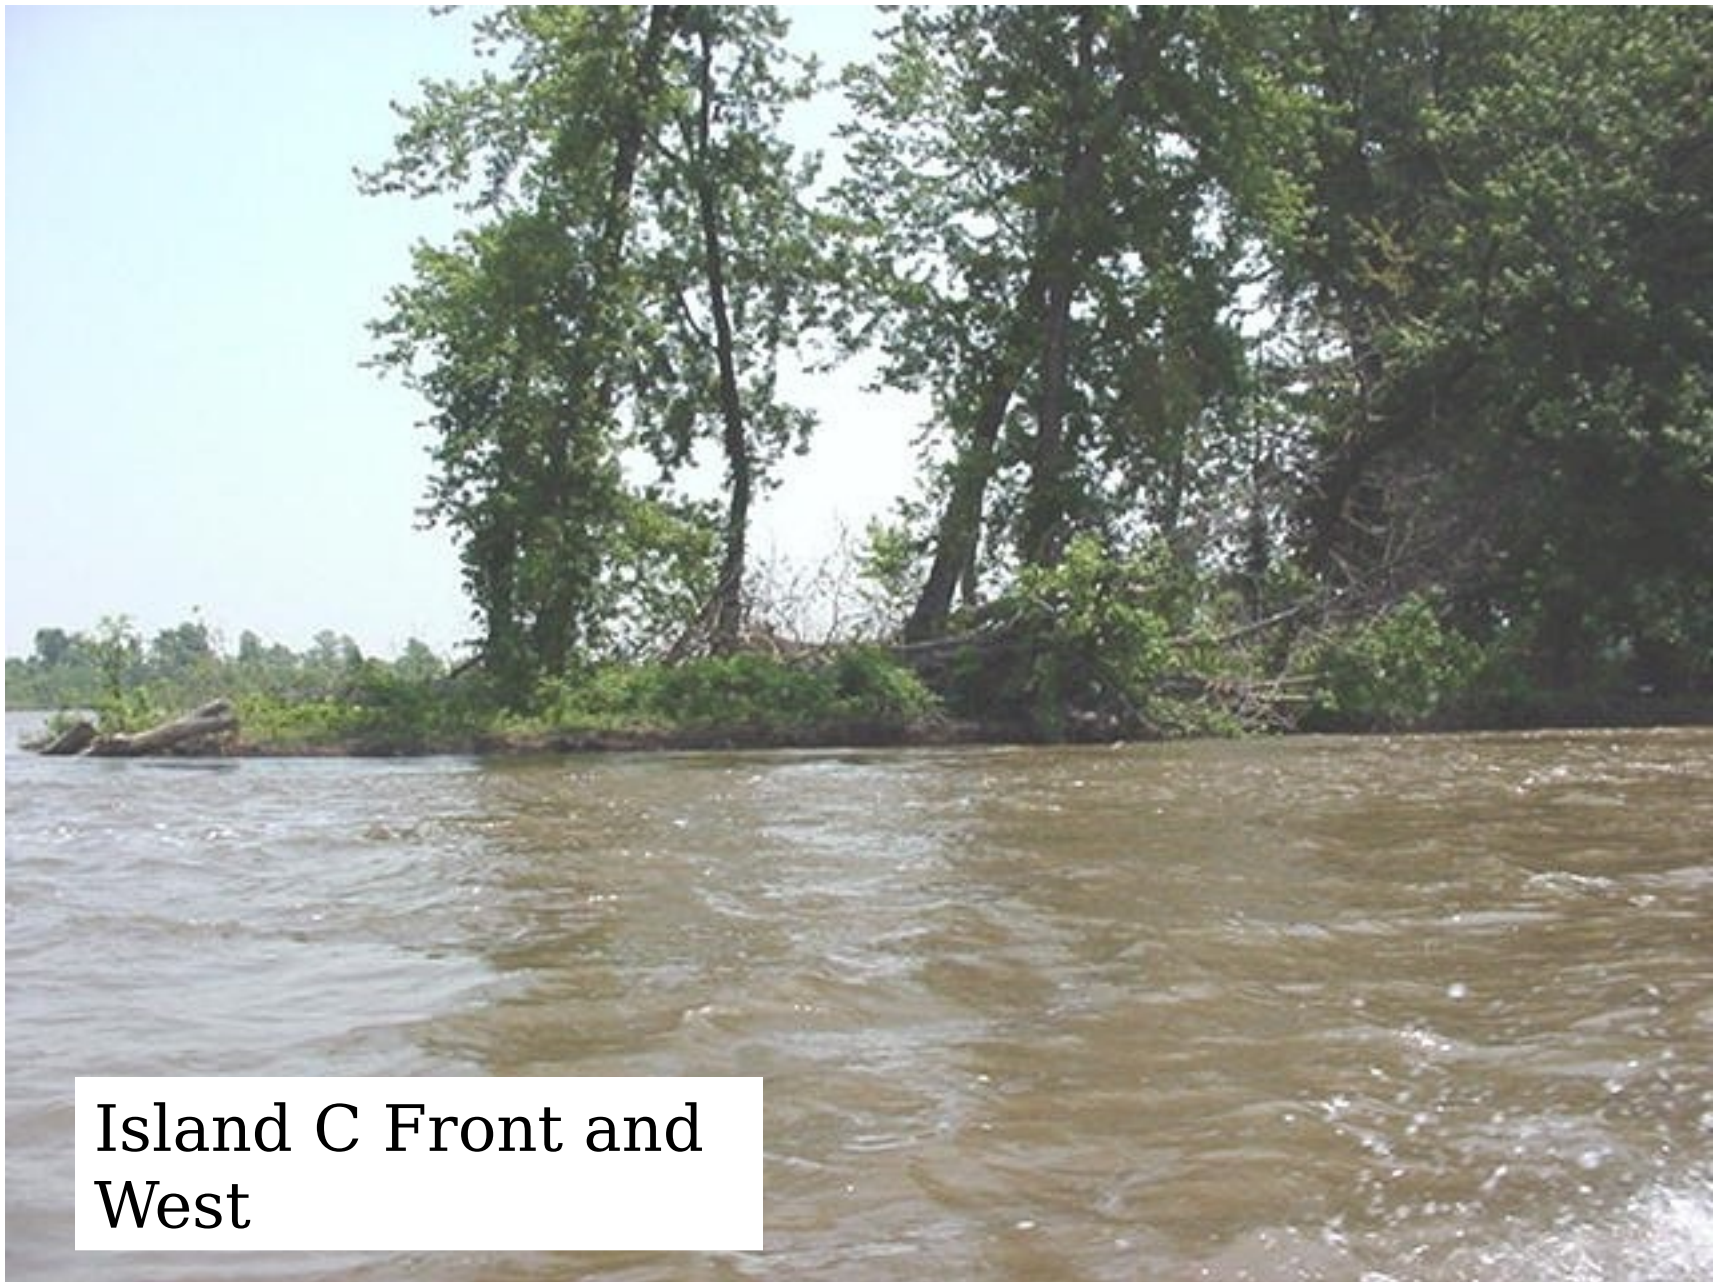
Island C Head  
End

- Significant Erosion since tree clearing.
- High flows in area.
- More rock is anticipated to be required.
- Rock fill is required for this island.
